Yacht SURVEY REPORT “CARPE DIEM.”

The following Survey Report is given without prejudice for and on behalf of Mr. Bill Lindsay at his request on 23/5/2016 at 23 Moolooloa Island, Minyama, and on the hardstand at Lawrie’s Boat Services, Kawana, Queensland.

Name : Carpe Diem
Type : Blue Water 400
Builder : David Bradburn
Designer : Joe Adams
Launched : 1995
LOA : 40’3” (12.27m)
LWL : 35’ (10.67m)
Beam : 13’ (3.94m)
Draft : 6’3” (1.9m)
Displacement : 10920Kg

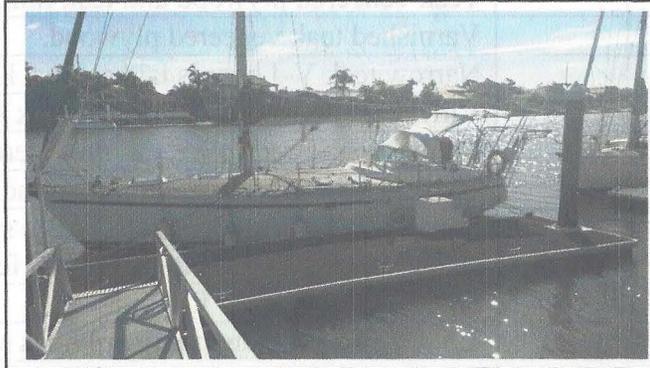
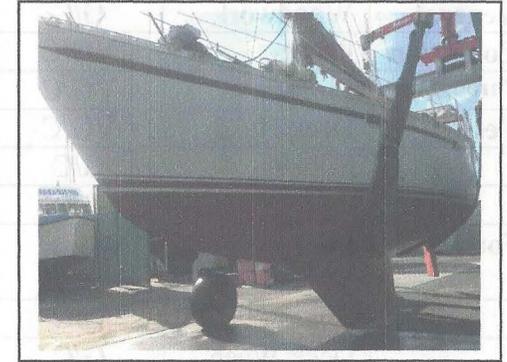
Construction -Hull : Deep draft Carvel, moulded fibreglass reinforced plastic with plywood bulkheads and glass-over-plywood frames. Vessel is fitted out in Custom built timber and teak veneered plywood and trimmed with teak.

- Deck and Cabin : Moulded FRP with end-grain balsa sandwich. Deckhead and cabin are lined with off-white vinyl in panels trimmed in teak.
- Rig: Masthead sloop, aluminium mast and spars. It has stainless steel standing and running rigging and synthetic rope halyards.
